**Subject:** Resolution Accepting the Finding of Necessity Study for the Goulds/Cutler Ridge Area and approving the preparation of a Community Redevelopment Plan

This Finding of Necessity (FON) report assesses conditions of slum and blight in the Goulds area in order to determine if the formation of a Community Redevelopment Area and a Community Redevelopment Agency are appropriate.

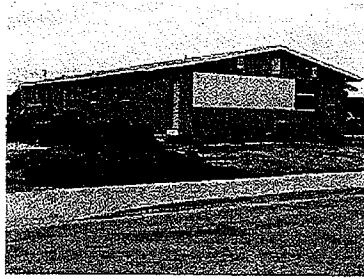
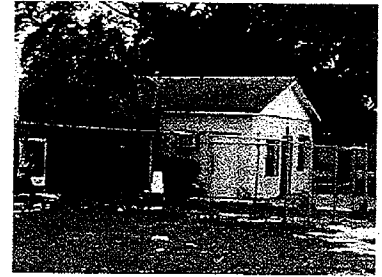
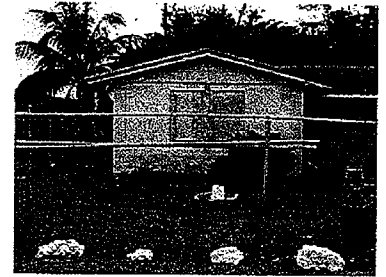
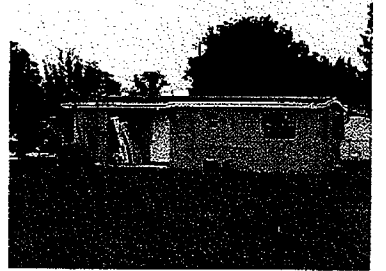
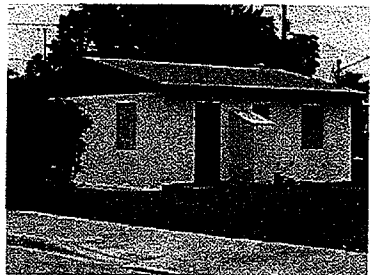
Figure 4A  
Housing Photographs  
Goulds / Cutler Ridge CRA

In summary, 87 of the 2,880 residential buildings are showing signs of deterioration, and 13 are dilapidated. Together, the deteriorating and dilapidated buildings are 4% of the stock of residential structures in this area. On a typical block of 16 to 20 lots, this would mean that approximately one building is deteriorated or dilapidated; however, these conditions are not evenly distributed throughout the area. The heaviest concentration of deteriorated and dilapidated structures is in the section south of old Cutler Road (SW 220<sup>th</sup> St.) to SW 224<sup>th</sup> Street, and west of SW 114<sup>th</sup> Avenue. The second highest concentration of poor physical conditions is in the West Goulds sub-area, in the section east of SW 122<sup>nd</sup> Avenue and north of SW 220<sup>th</sup> Street. Examples of the quality and condition of the residential properties are shown in **Figures 4A and 4B, Residential Site Photographs.**

This level of deterioration, although not a blighting condition by itself, is in combination with other defective physical conditions, a contributing factor to blight in the proposed Goulds CRA.

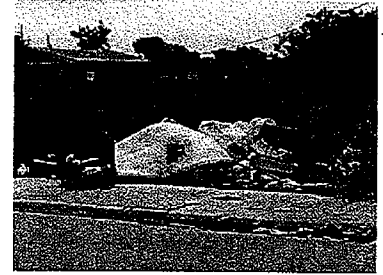
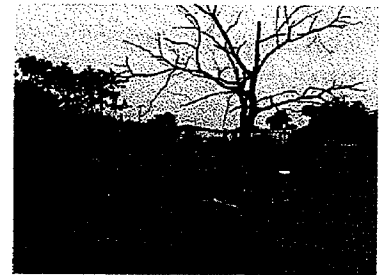
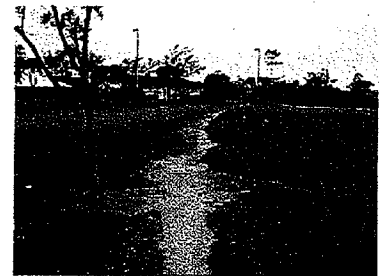
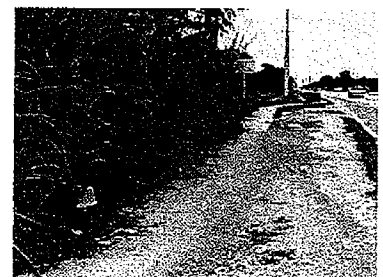
Vacant lots diminish a community's value because they attract dumping, and are usually overgrown. The dumping and trash, in combination with overgrown tall grasses can easily create a higher risk of fire hazard, as well as attracting vermin that create other health risks. Finally, vacancies under these conditions may contribute to higher crime due to their provision of large spaces that are hidden from view and not easily patrolled by police. Examples of the trash and dumping that vacant lots attract are illustrated in **Figure 8, Trash Site Photographs**.

There are 680 vacant residential parcels out of 3,223 according to Property Appraiser data that are within the proposed Goulds CRA. Based on the physical conditions survey, approximately 20% to 30% of these have some amount of trash, and dumping upon them. As this can compromise general public health, safety, and endanger adjacent properties by fire or propagation of insects, these conditions are a contributing factor to blight.

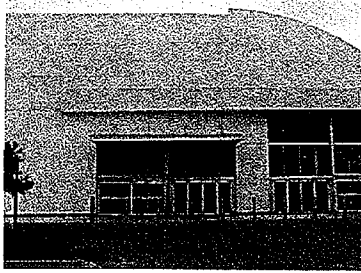
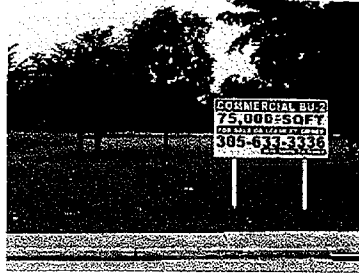
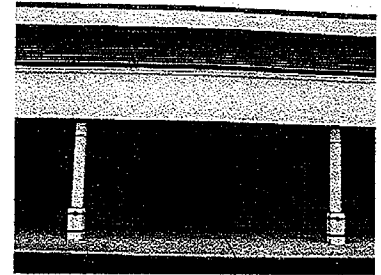
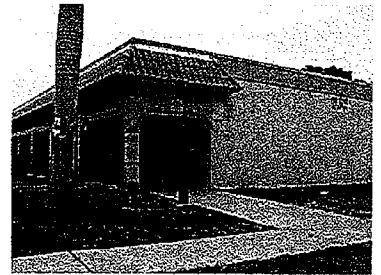
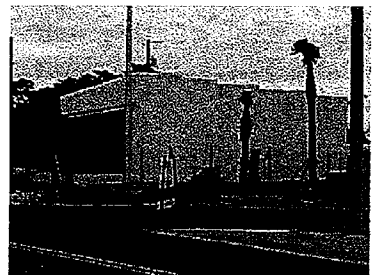
- The presence of large institutional facilities such as the South Dade Government Center and public housing units that are tax-exempt.
  - Vacant retail uses scattered throughout the study area as illustrated in **Figure 10, Vacant Retail Photographs.**
